USS TURNER JOY RESTORED TO NAVAL STANDARD

TURNER JOY HULL OVERHAUL

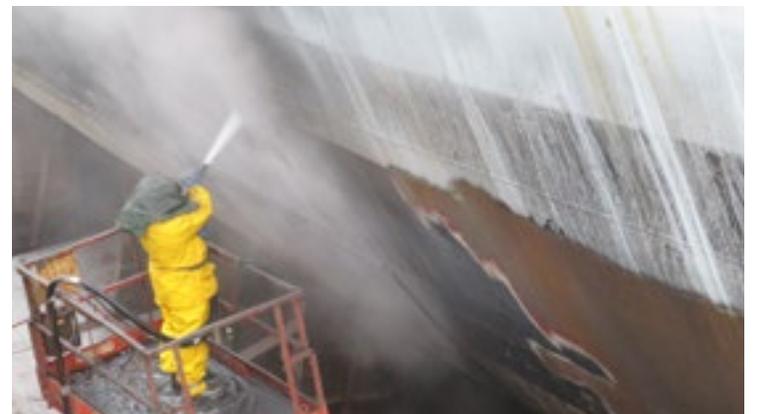
Blasting Black Diamond Iron Silicate, the team was able to remove 25 tons of sea growth, as well as the 15-year epoxy paint covering the bottom half of the ship, in only ten days. Once the hull surface was blasted to a clean raw steel, the crew measured and repaired thinning walls, cracks, and holes.

To complete the project, the crew blasted the 418-foot starboard side clean of the faded and chipped paint and rust. Once they reached the desired profile, the Drydock team restored the Turner Joy to its former glory with a fresh application of paint.
